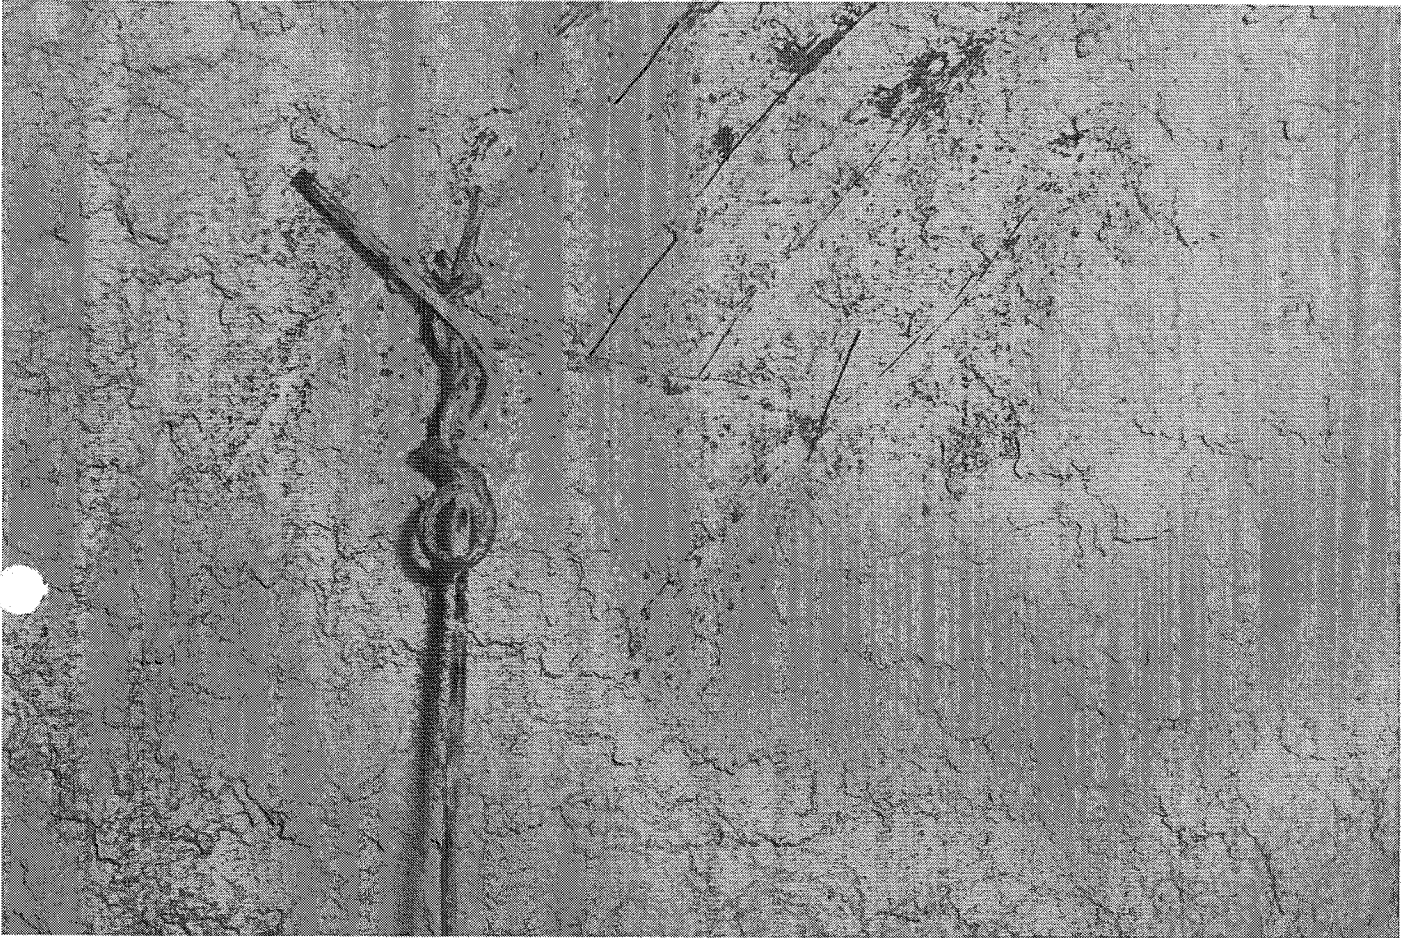
53. 4th Floor vacant center ste - Disturbed fireproofing next to hanger wire on corrugated decking above suspended ceiling

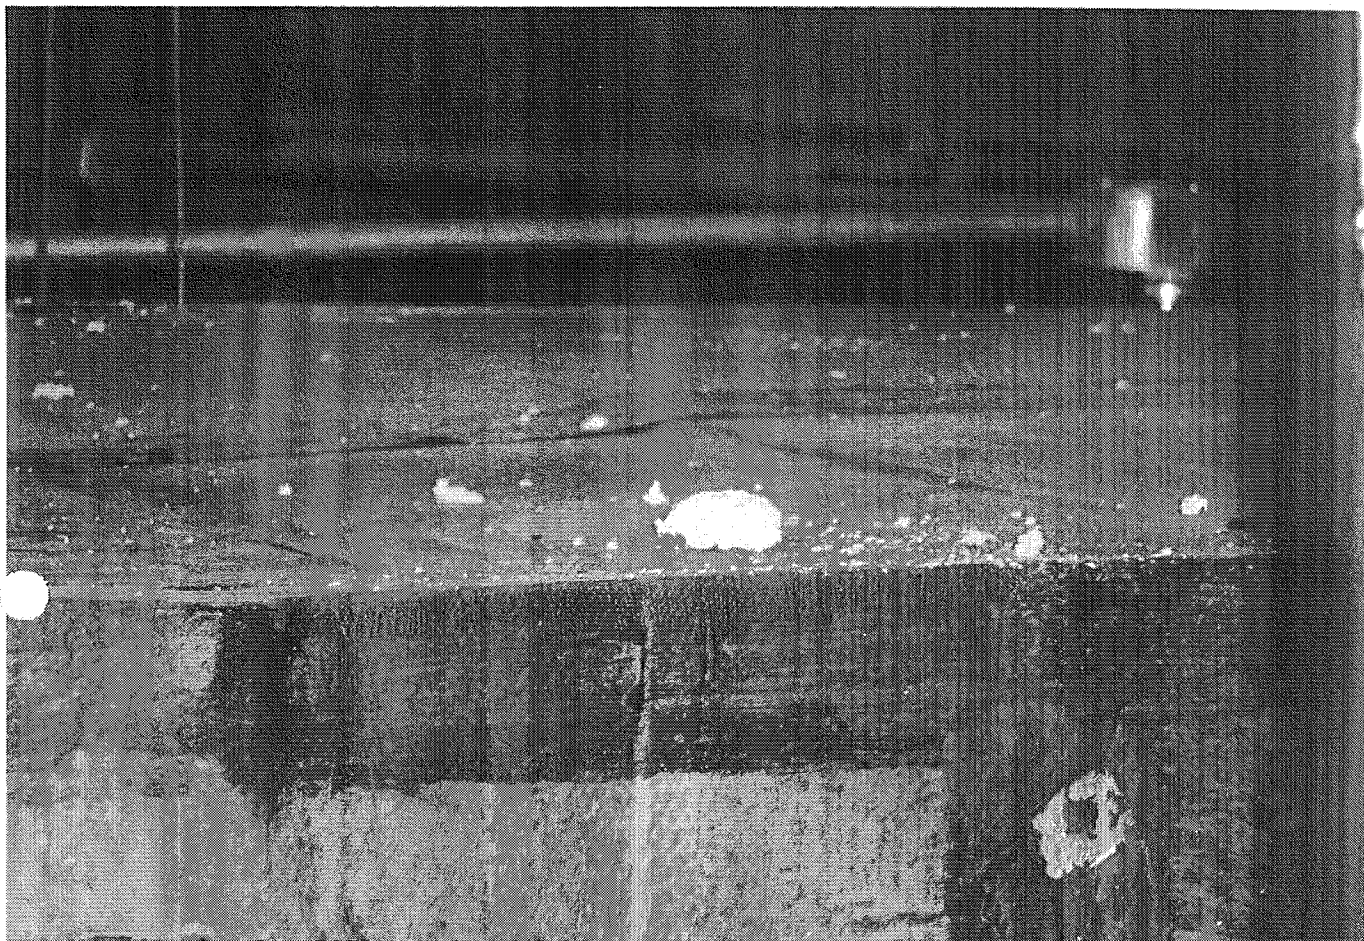
54. 4th Floor vacant center ste - Close-up of fireproofing debris on top of HVAC duct above suspended ceiling

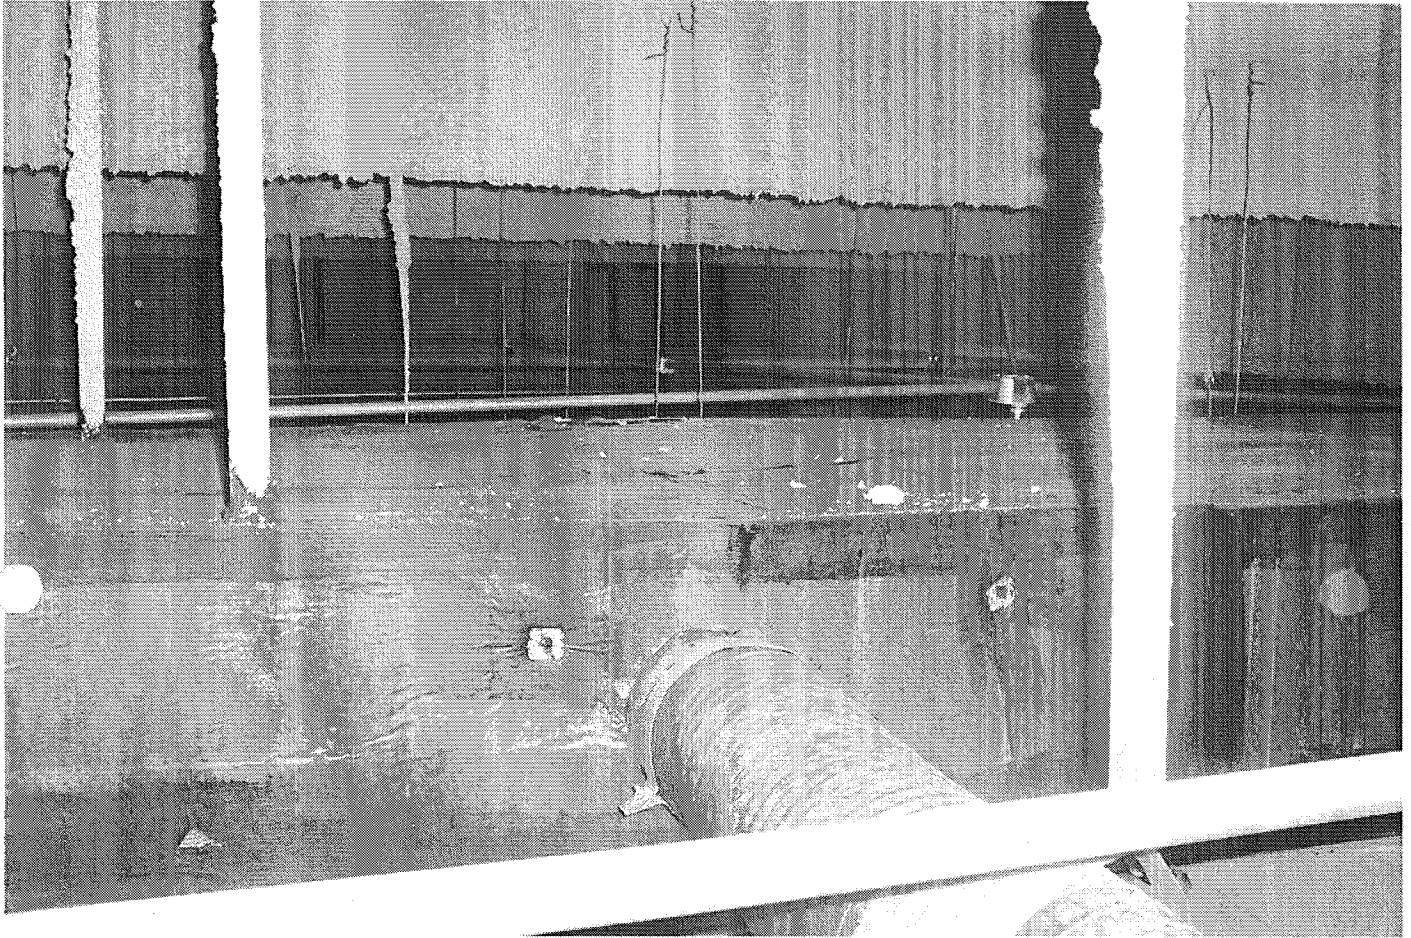
55. 4th Floor vacant center ste - General view of fireproofing debris on top of HVAC duct above suspended ceiling

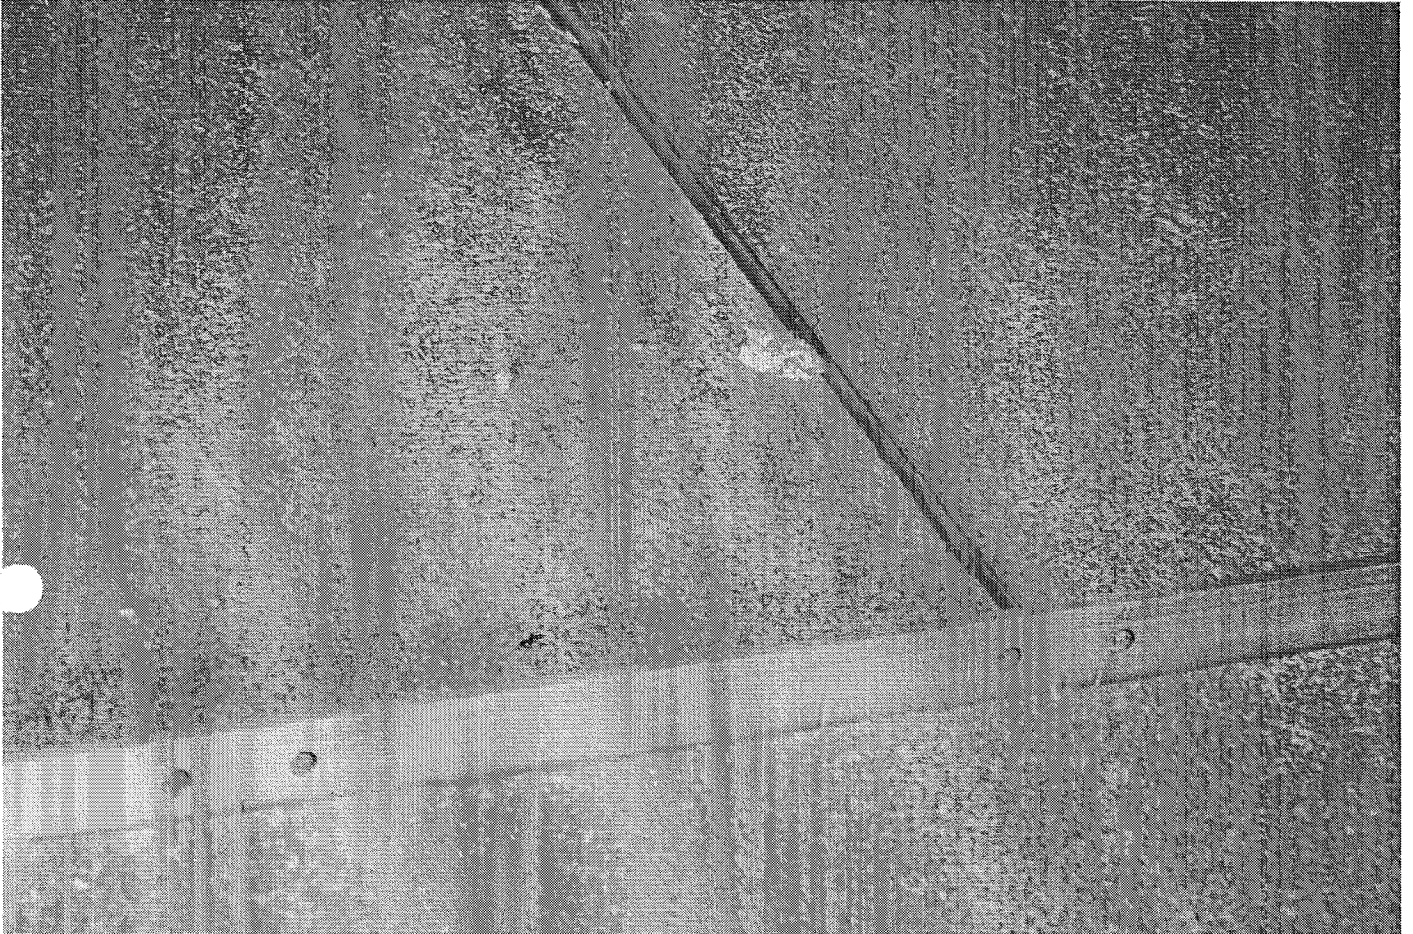
56. 4th Floor vacant center ste - Close-up view of fireproofing debris on top of suspended ceiling

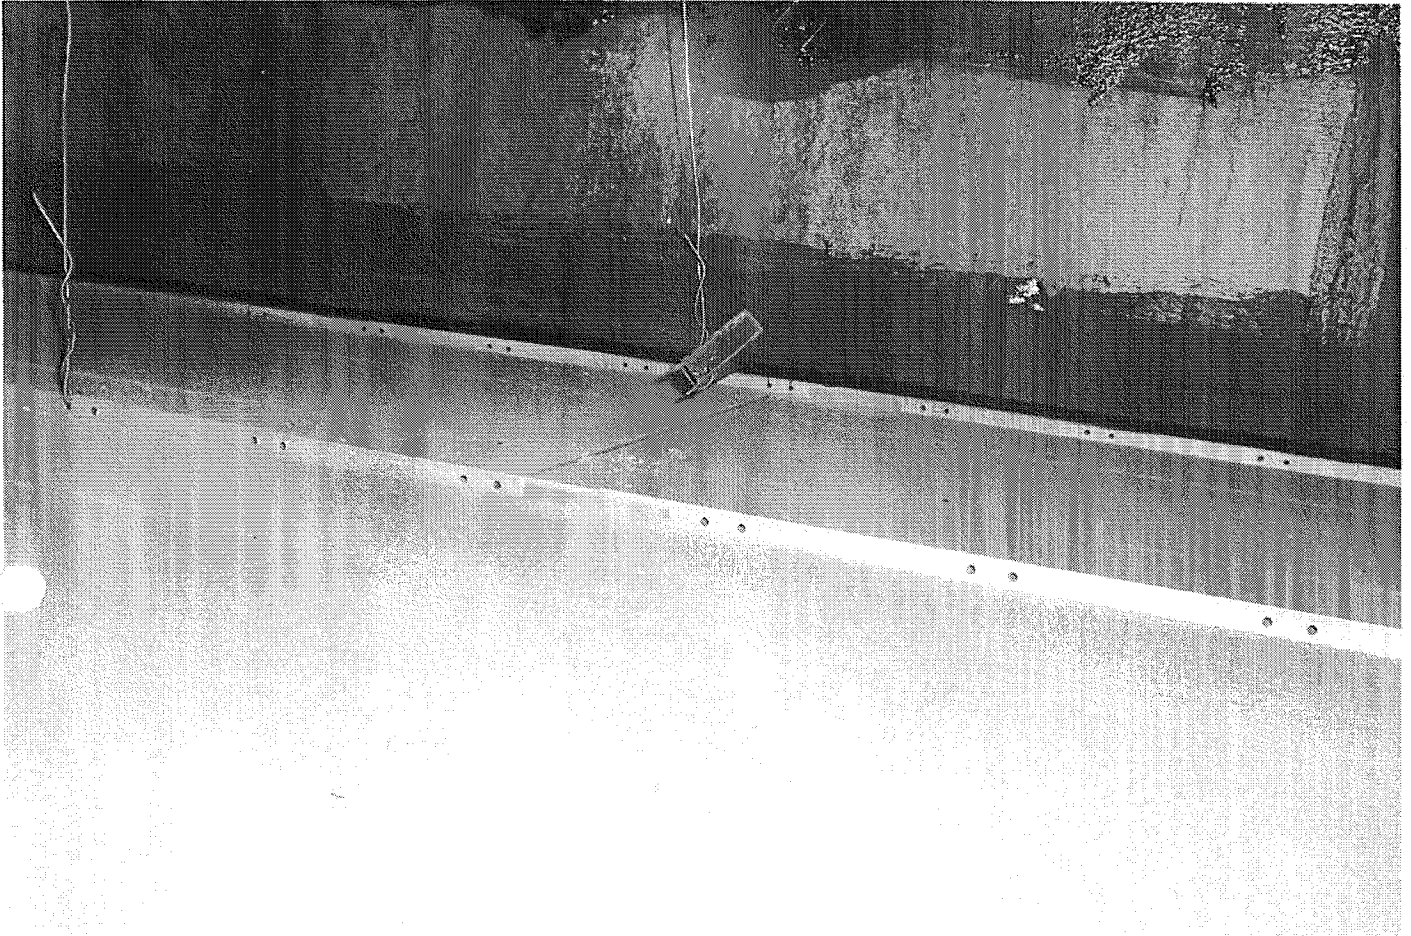
57. 6th floor center suite 600 - View of fireproofing debris on top of suspended ceiling

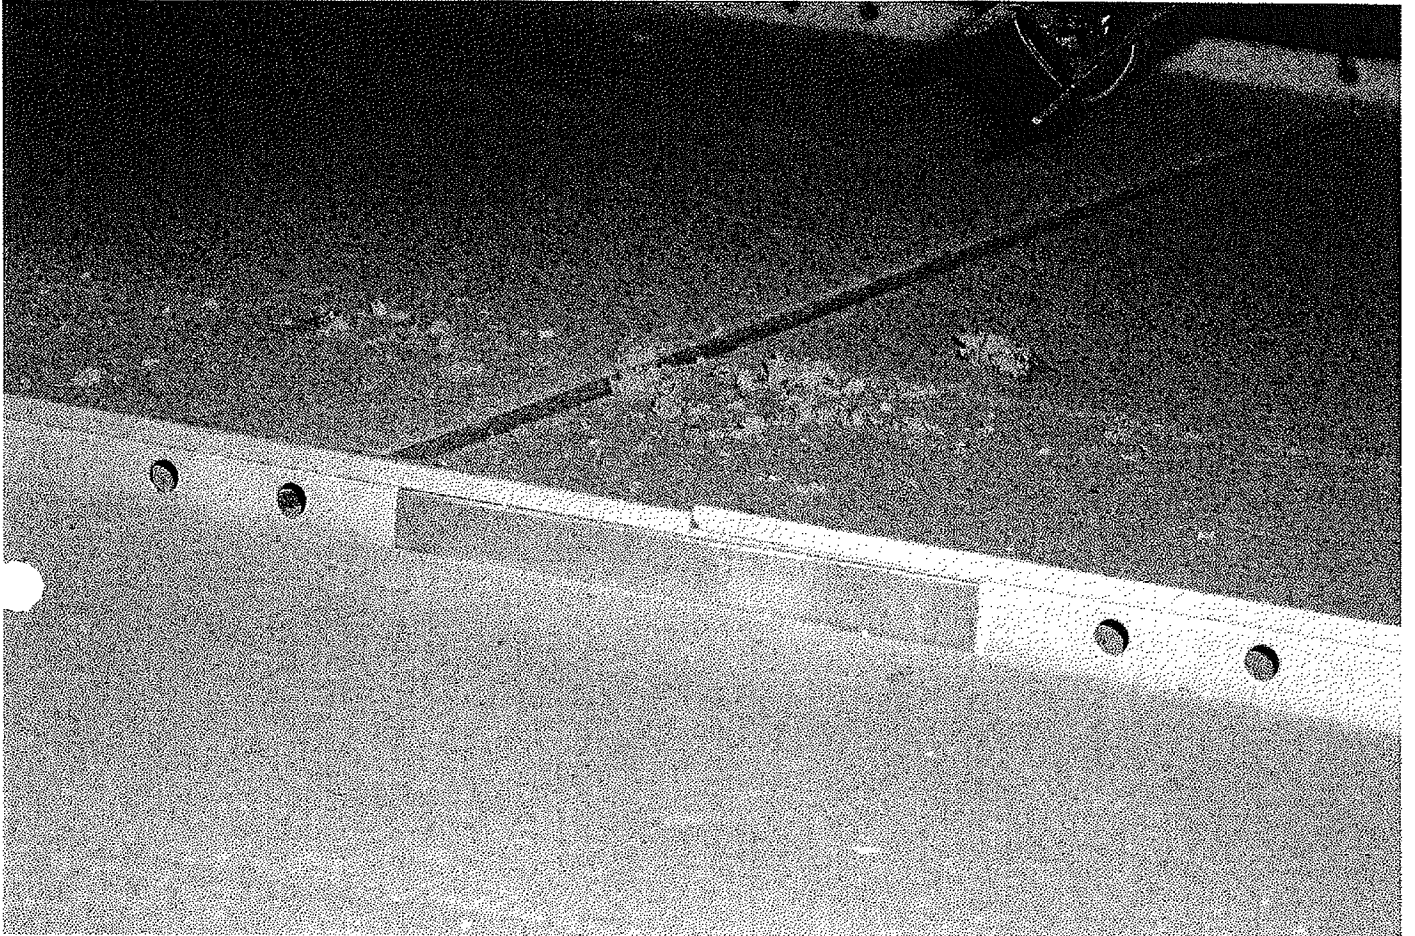
58. 6th floor center suite 600 - Close-up of fireproofing debris on top of suspended ceiling
